FINAL REPORT REMEDIAL INVESTIGATION

BUILDING 231

CAMP NAVAJO BELLEMONT, ARIZONA

July 1999

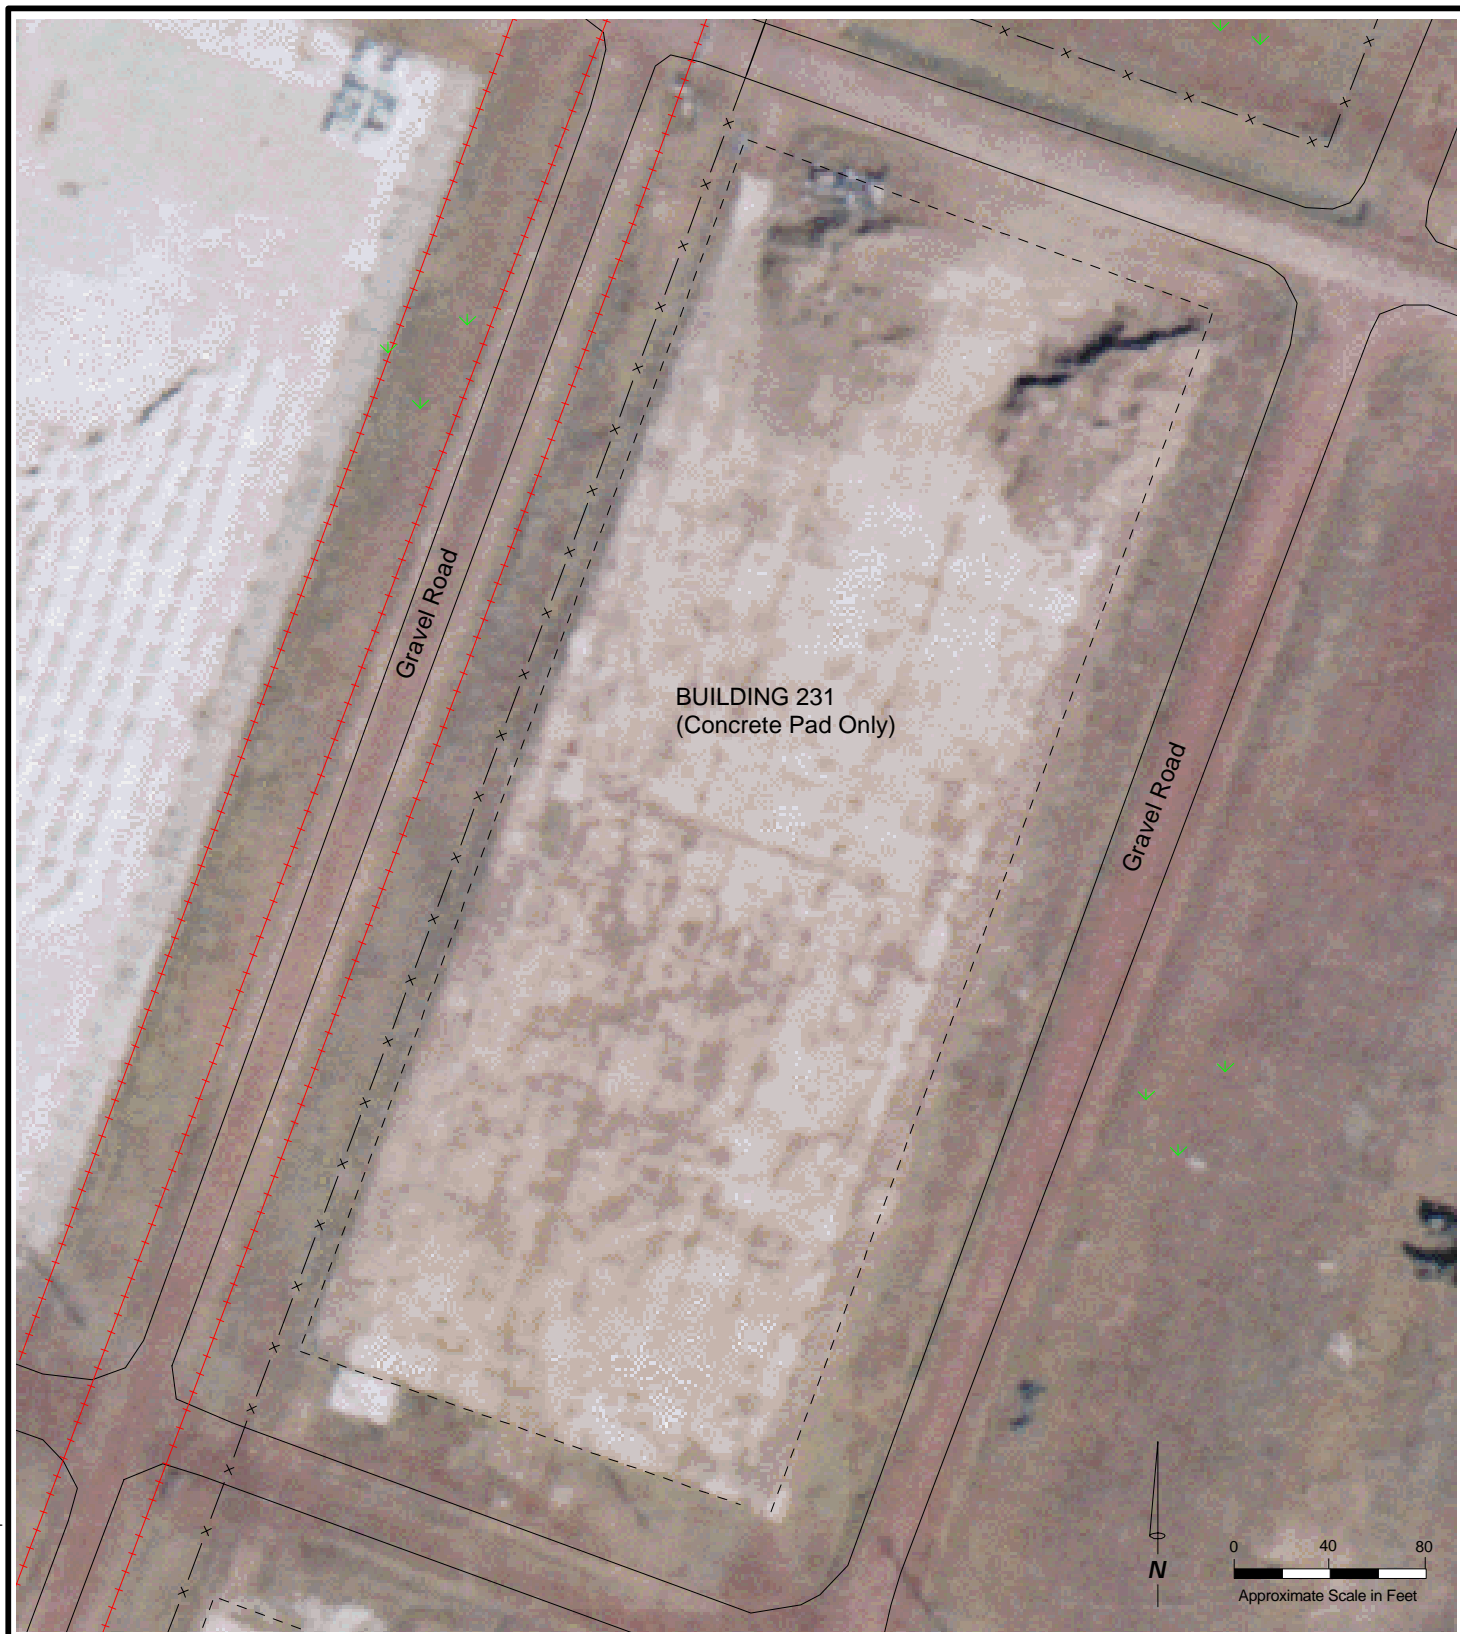
Figure 1-2

Building 231 - Former Mercury Storage

Site Plan

GSA mercury stocks were housed in Building 231 or 233 (Figures 1-2 and 1-3), or both, from 1953 until they were moved to Igloo Area H in 1960. The mercury warehouse building collapsed in a snowstorm in 1967, and the superstructure was subsequently removed (EBASCO 1990). Mercury leaks were reported to have occurred in the GSA warehouse where mercury was stored (USATHAMA 1979). In 1979, there were visible traces of mercury in the cracked foundation of former Building 231 (USATHAMA 1979). The concrete pad at Building 231 (approximately 141,000 square feet) and the surrounding soil are potentially contaminated.

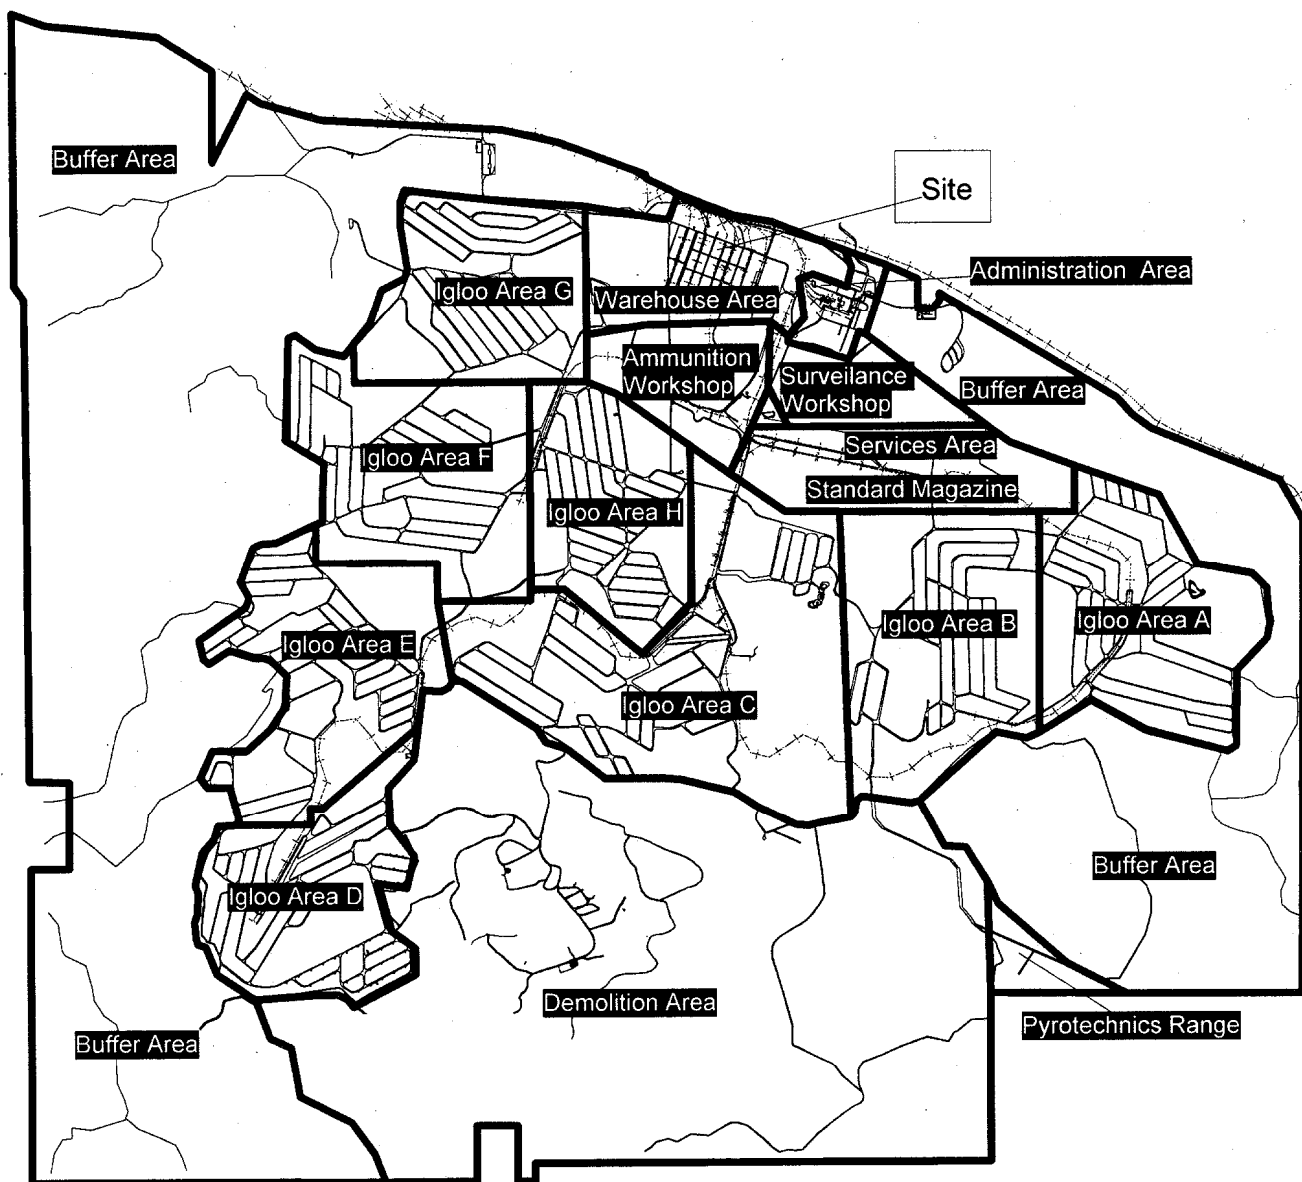
Figure 1-3

Building 231 - Former Mercury Storage Site Map

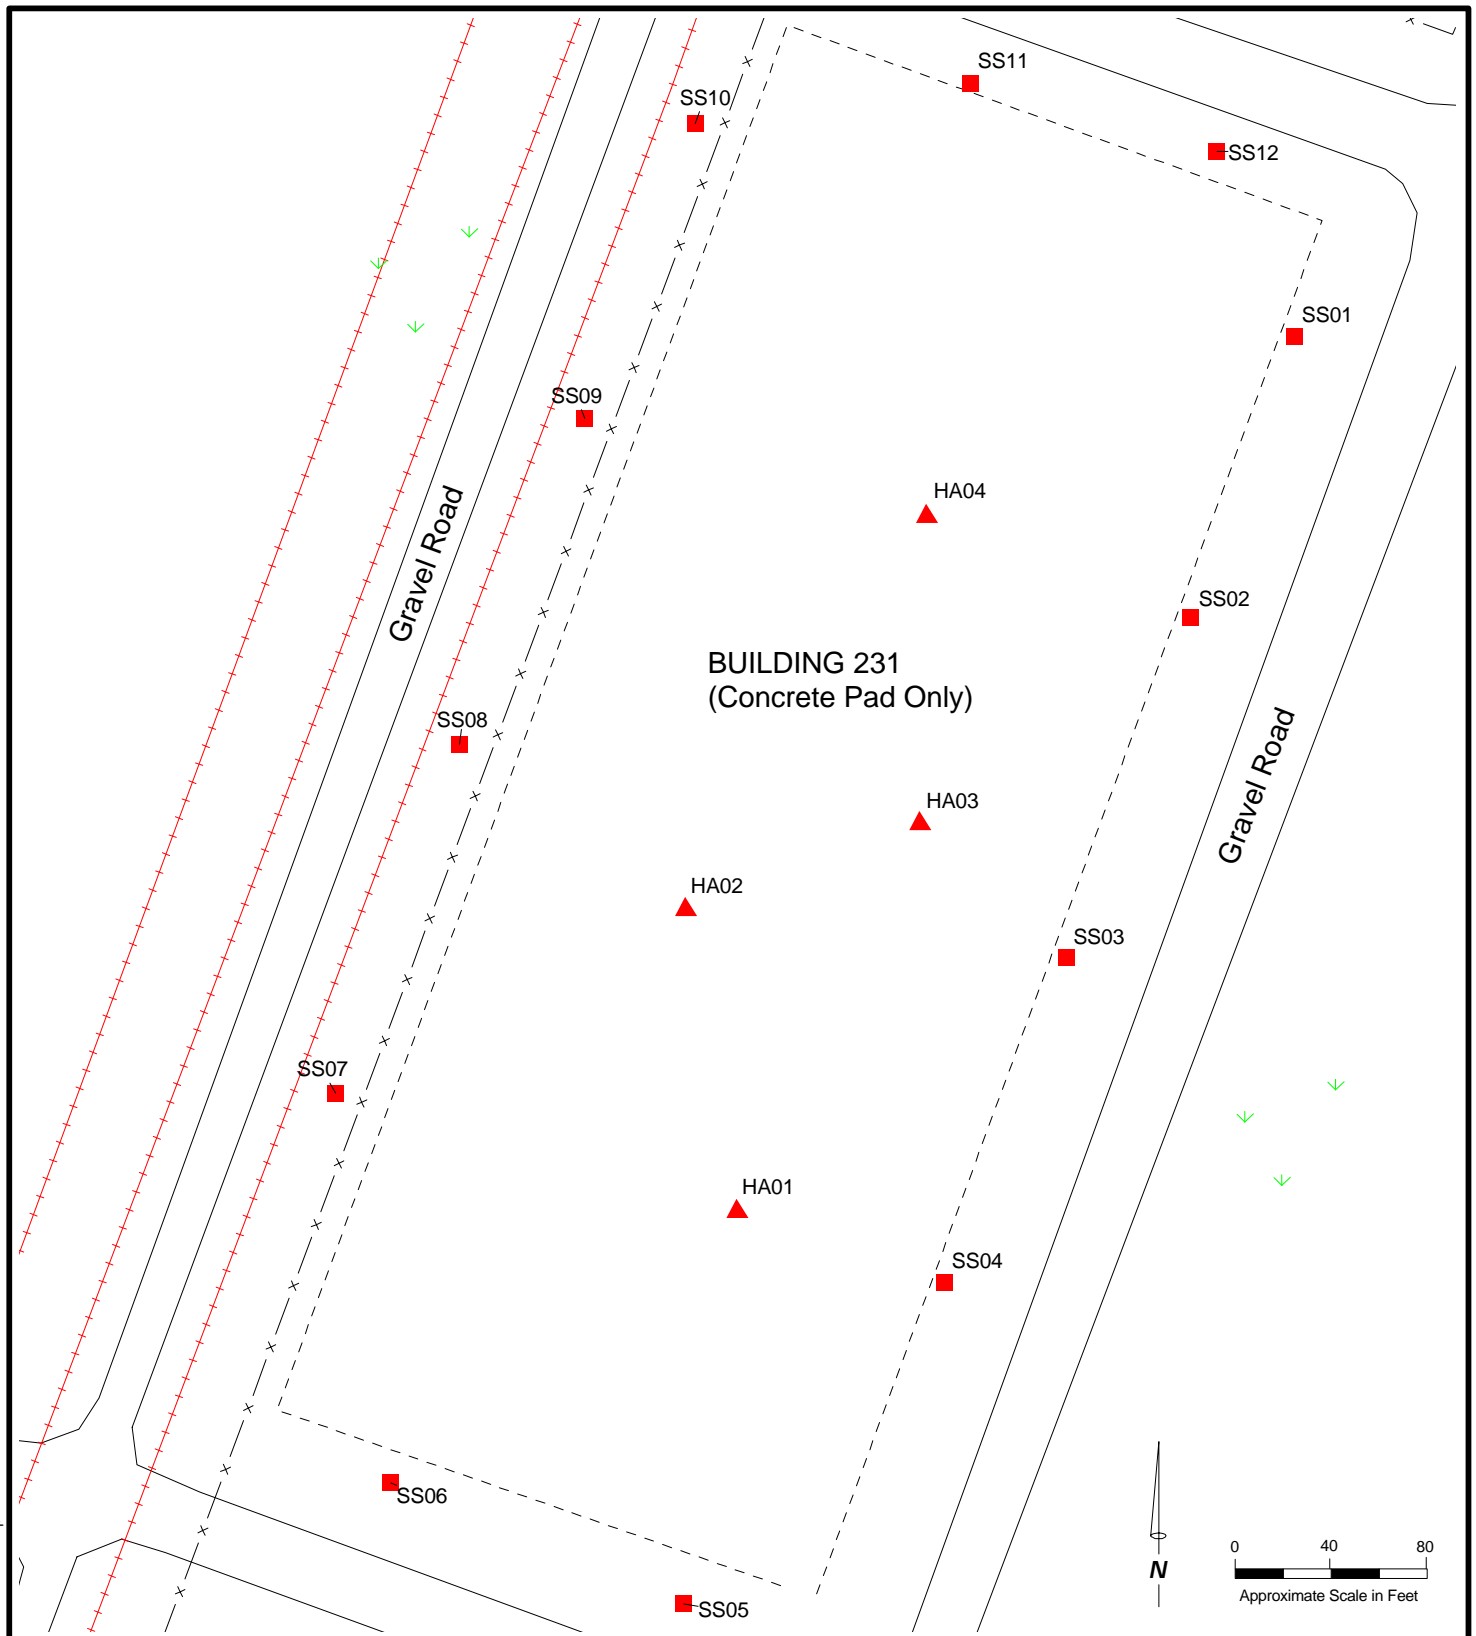
Building 231 - Former Mercury Storage

Investigation Plan

Surface soil sampling was performed outside each of the former doors to the building. Twelve surface soil samples were taken at the locations shown in [Figure 2-1](#). Samples were collected by driving a 2-inch by 12-inch California modified split spoon sampler, as described in Appendix C. As shown in [Table 2-1](#), surface soil samples were analyzed for mercury and pH. Two samples also were analyzed for bulk density and grain size.

Four hand auger locations were sampled within the building foundation. The hand auger borings were located in heavily cracked areas of the pad identified during the inspection (Figure 2-1). Hand auger sampling was done to a maximum depth of five feet bgs. Samples were collected at 0.5, 2.5, and five feet bgs from each location. Samples were collected by driving a 2-inch by 12-inch California modified split spoon sampler, as described in Appendix C. Soil samples were analyzed for metals and pH as shown in Table 2-1. Two samples also were analyzed for bulk density and grain size.

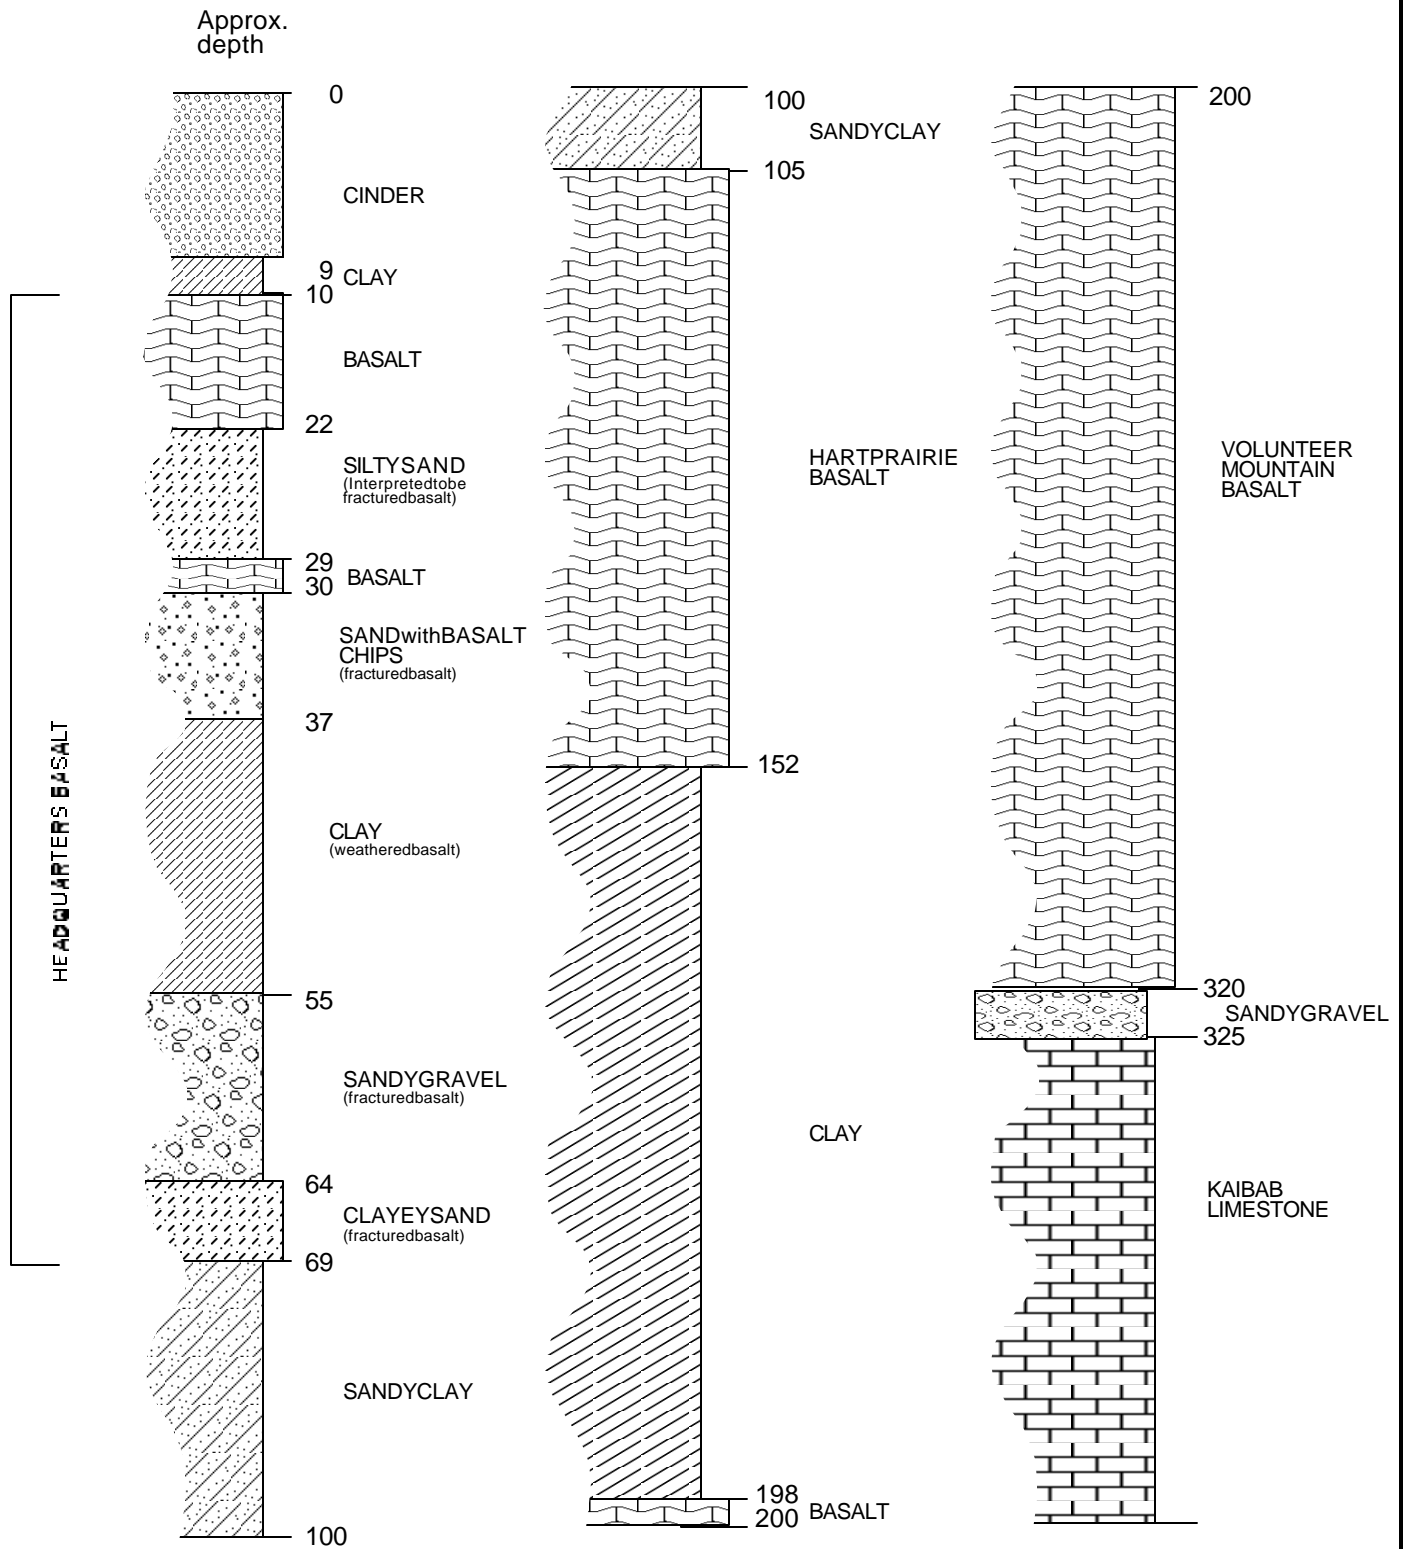
Building 231 Stratigraphy

The following description of the geologic units deeper than 20 feet is compiled from surface geologic mapping, from soil borings in other portions of the Warehouse Area, and from geophysical surveys (Figures 3-1 and 3-2) (Tetra Tech 1999a, 1999b). A monitoring well drilled in 1996 approximately 2,000 feet east of the site encountered a thin veneer (<10 feet) of clayey soil overlying a thickness of basalt. This basalt is interpreted to be the Headquarters Basalt which underlies the entire Warehouse Area as well as the adjacent Administration Area. The flow is estimated to be about 60 feet thick and overlies a thickness (<35 feet) of Camp Navajo Clay. The Camp Navajo Clay was deposited directly on top of a second basalt flow. This second basalt flow is interpreted to be the Hart Pairie basalt and is 45 feet thick. Below the second basalt is a second clay (45 feet thick) and a third basalt. The third basalt is interpreted to be the Volunteer Mountain basalt and is 120 feet thick. Below the third basalt is a thin zone of gravel and weathered Kaibab Formation (<20 feet) and the underlying Kaibab Formation.

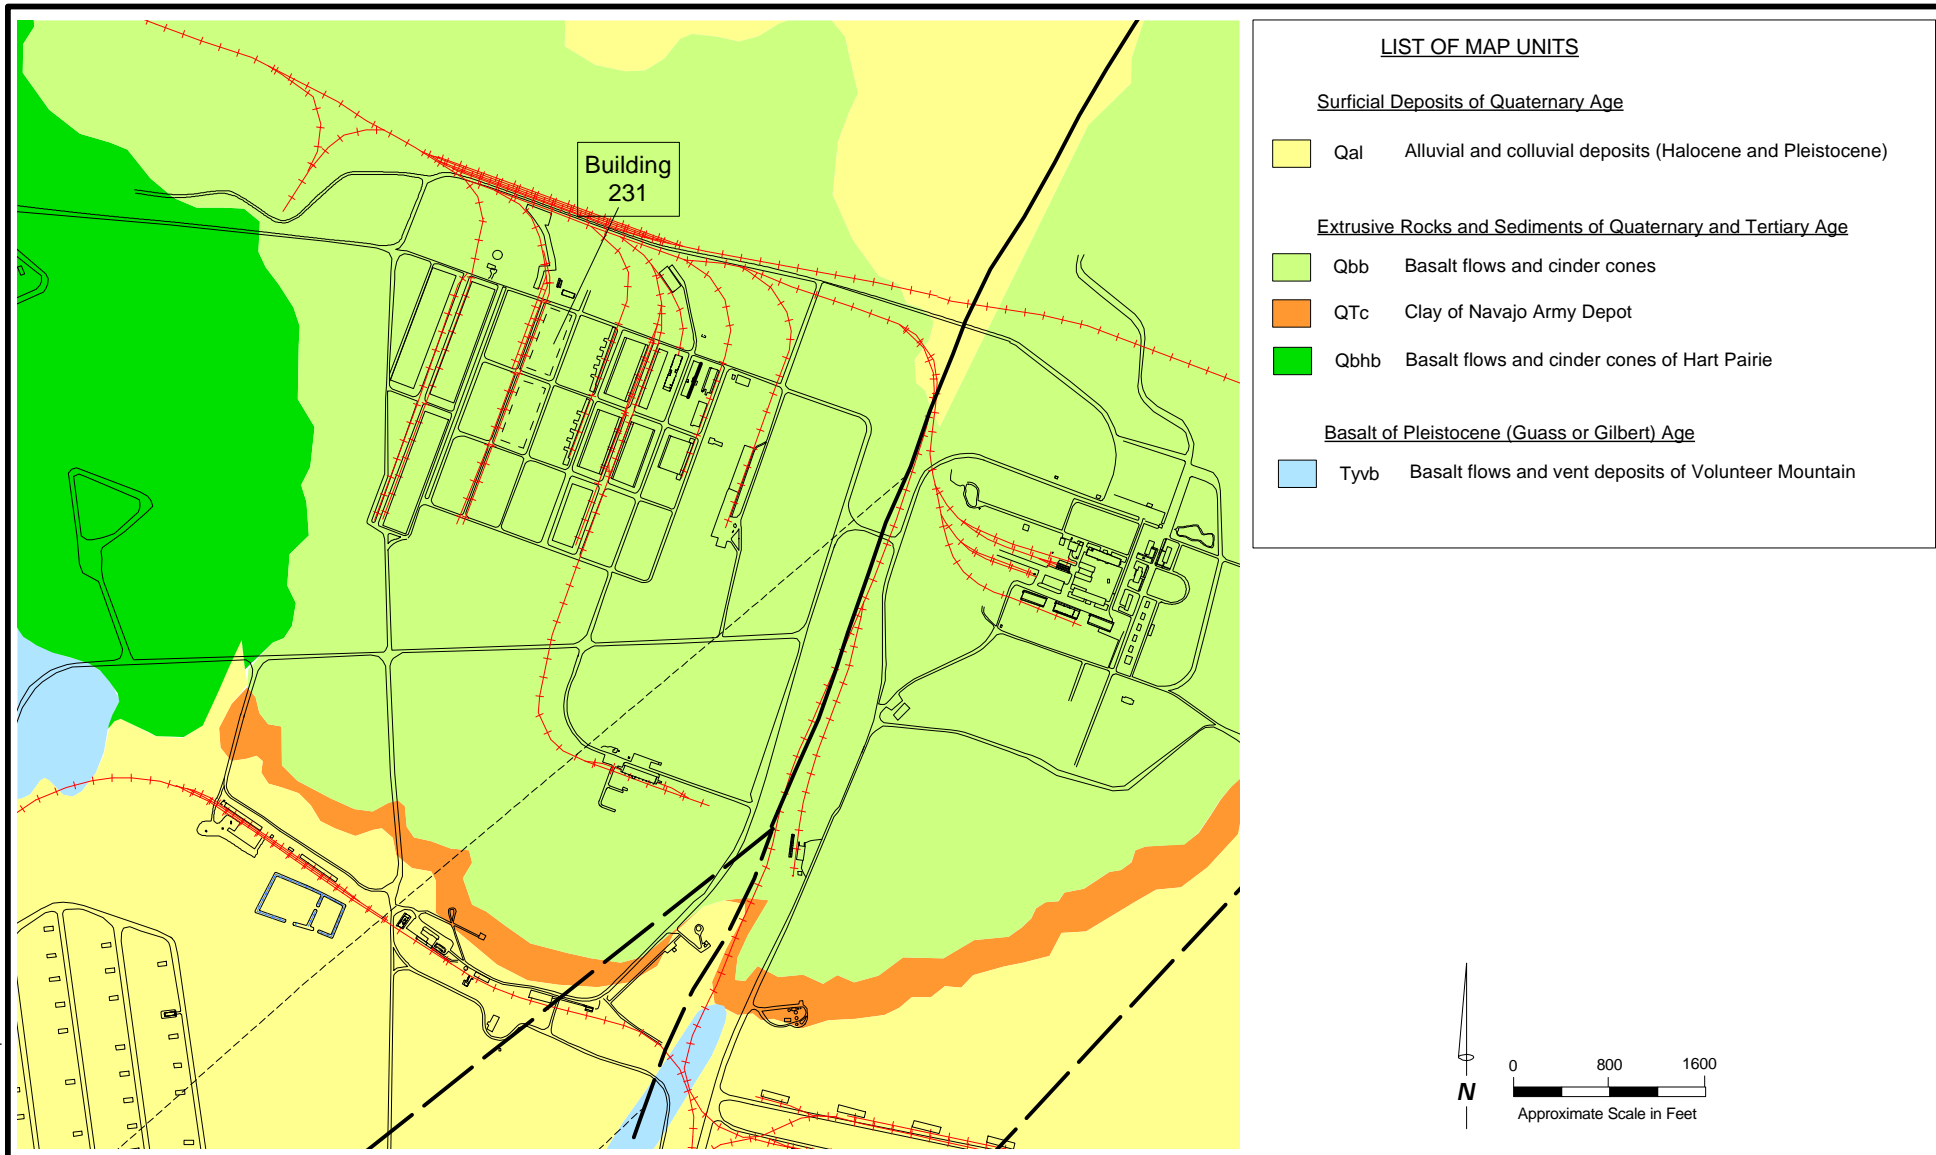
Figure 3-2

Warehouse Area Geology
